**RELIABILITY ANALYSIS OF FORTY-FIVE STRAIN-
GAGE SYSTEMS MOUNTED ON THE FIRST FAN
STAGE OF A YF-100 ENGINE**

by Raymond Holanda and Lloyd N. Krause

Lewis Research Center

September 1977

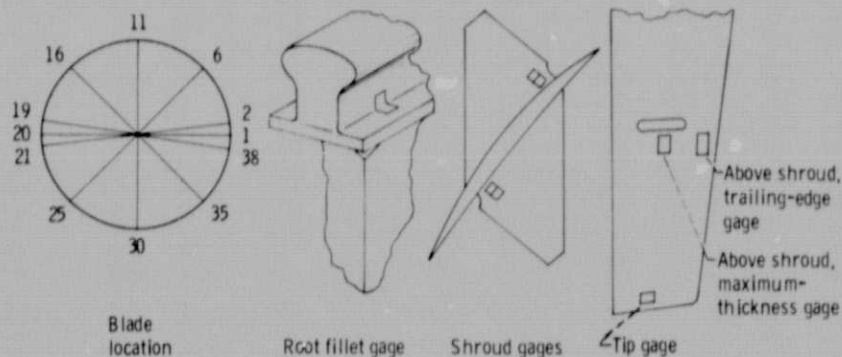
Figure 1. - Strain-gage location map.

Table III shows the 25 gage system failures tabulated according to the gage sensor location on the blade. No location was exempt from a high failure rate, and the rates are distributed with a small deviation about the mean. Table IV lists these gage failures according to installation method and installer. Flame-sprayed gage installations suffered significantly higher failure rates than did the epoxy installations. Table V shows the gage resistance measurements taken at various stages of the investigation. On the basis of these measurements and the visual inspection of the blades, the types of gage failure can be isolated and grouped as shown in table VI. The failures were analyzed according to these groups.

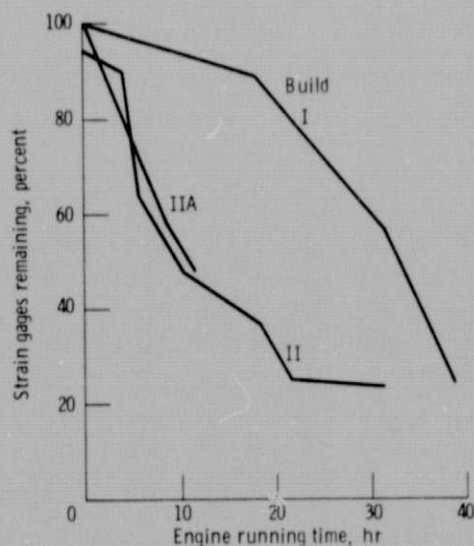
Figure 2. - Strain-gage failure rates for various builds.

The running schedule of the engine for build IIA is shown in table II. Inlet air temperatures up to 340⁰ F and rotor speeds up to 8500 rpm were experienced. At the conclusion of the testing, 23 strain gages were recorded as inoperative at the control room monitoring station. In addition, an inspection added two other gages to the failure list, one that had been intermittent and one with a section of lead wire hanging loose whose failure was imminent, bringing the total apparent failures to 25. The failed gages are shown by the shading on the gage location map (fig. 1), and the rate of gage failure is compared in figure 2 with the rates of failure for builds I and II. The time in flutter for build IIA was about 20 minutes.

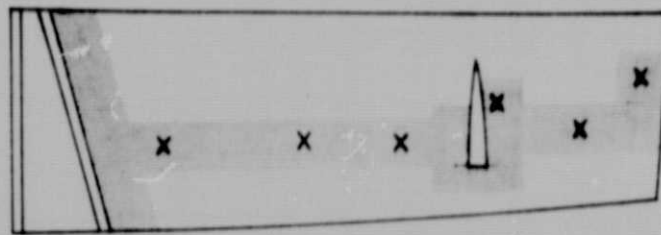
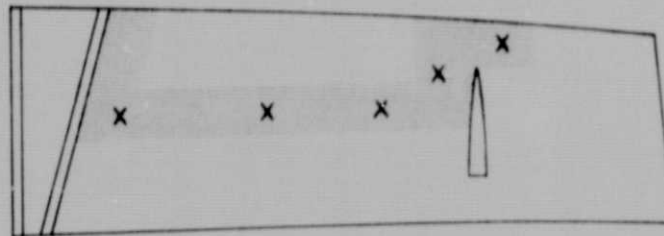
Figure 3. - Strain-gage installation patterns (shaded areas), indicating locations of thickness measurements.

The erosion problem was evaluated by thickness measurements made at various points on the blade (fig. 3) and by visual inspection. The convex side of the blade showed negligible erosion for both flame-sprayed and epoxy materials; the concave side showed high erosion rates.

Assuming zero erosion for the convex side, and assuming that the initial thicknesses of concave and convex installations were the same for a particular blade, the erosion rates for the concave side were determined from the thickness measurements. The results showed a 35-percent erosion rate for epoxy on the concave side between the root and the shroud during the 11 hours of testing. An extrapolation would lead to 100-percent gage failure in a 50-hour test, assuming a linear erosion rate. The flame-sprayed installations eroded about 10 percent, but a greater variation from gage to gage makes this value less certain. Indications are that few failures would be attributed to this mode in a 50-hour test.

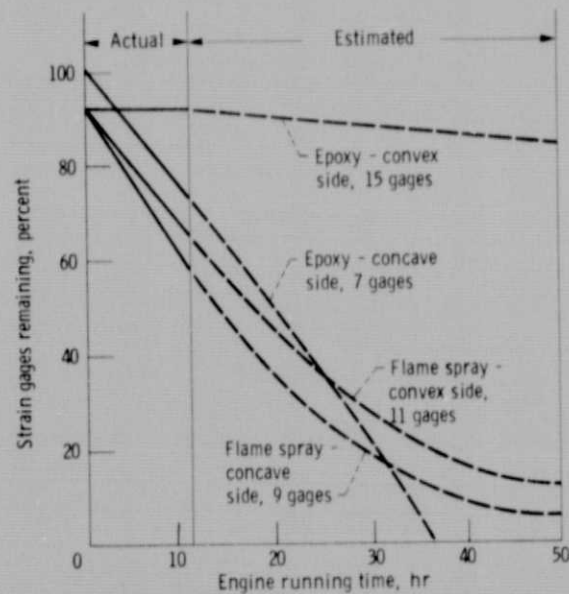
Figure 4. - Strain-gage failure rates for build IIA, failures on the blade. (Figure does not include three root gages.)

A strain-gage failure curve of the type shown in figure 2 appears in figure 4. The failures include only those occurring on the blade, and they are grouped according to the installation method and the side of blade on which the gages were installed. The curves have been extrapolated to 50 hours of engine running time. The extrapolations are based on post-test examination of the blades and take into account such things as erosion rates and rates of increase of gage resistance. The curves dramatically depict the superiority of epoxy-cemented gages on the convex side of the blade both in the actual and in the estimated portions of the curve.

The primary cause of failure in flame-sprayed gages is high gage resistance, probably from high stress levels imposed by the severe running conditions of the flutter program. Temperatures encountered in these tests are considered low for flame-sprayed installations. During portions of the program, some strain gages were subjected to strain levels up to about ± 600 microstrain. This value of strain is near the upper endurance limit for conventional flame-sprayed installations, assuming a typical vibration frequency of 1000 hertz and 20 minutes of flutter time for build IIA. It is possible that gage location on the blade could be changed to deal with this problem.

Because of their superior fatigue strength, the epoxy-installed strain gages were not adversely affected by these strain levels. The primary cause of gage failure in epoxy-cemented strain gages was erosion, but only on the concave side. Wherever possible, a high-endurance foil gage cemented with epoxy on the convex side of the blade should be used. Epoxy-cemented gages maintain a fatigue strength advantage over flame-sprayed installations up to a temperature of about 500⁰ F.

1. The primary cause of blade-mounted failures of the epoxy-installed gages was erosion, but only on the concave side (pressure side) of the blade. Erosion rates on the convex side were mild enough for such an installation to withstand a 50-hour test. It is recommended that epoxy-cemented gages mounted on the convex side be used whenever testing programs operate within the temperature
